# WRIGHT GROUP INC.

August 9, 2010

2125 Pine Street  
Philadelphia, PA

57545

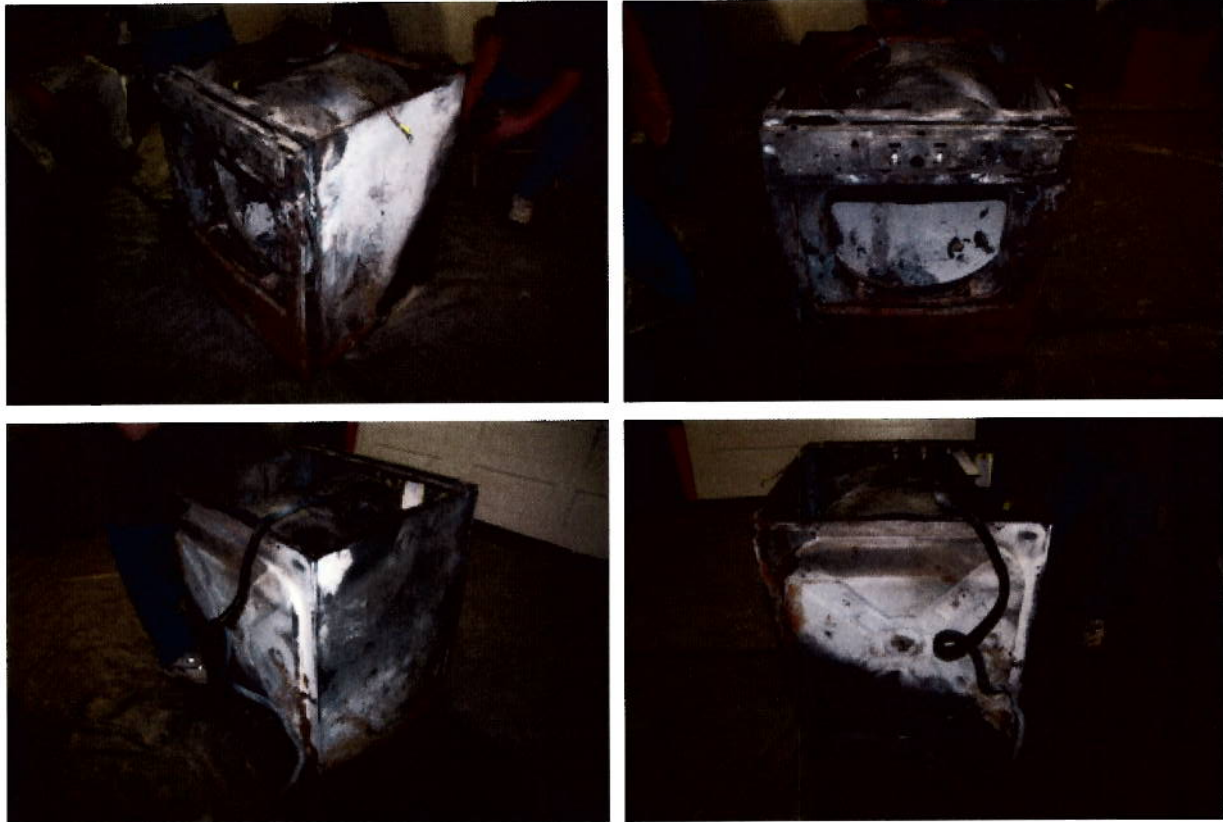
**Exterior of Subject Dryer**

The exterior examination of the dryer revealed that the heaviest oxidation and heat damage to the right front corner was consistent with the trap duct/blower housing being consumed during the fire. The paint on the left side was damaged. The right and front sides were the most heavily oxidized. The top panel was not attached or included with the evidence. Based upon the scene photographs, the top panel was removed at the time the dryer was installed at the property to allow it to be installed under counter, beside the front-loading washing machine. In addition, the dryer door was no longer attached. All exterior fire patterns were consistent with the fire originating within the dryer.

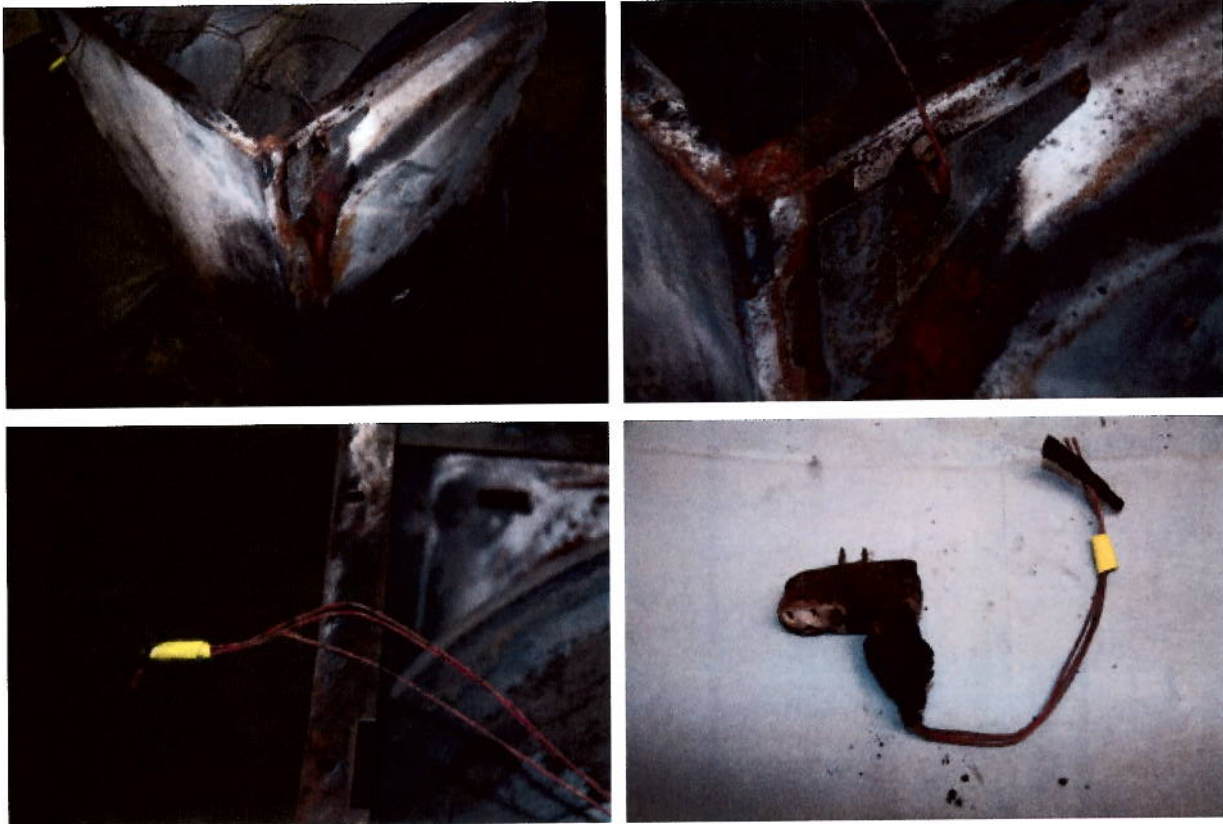
**Power Cord**

Examination of the rear of the dryer revealed the louvered access panel was in place and all of the fasteners on the rear of the cabinet were OEM. The dryer was equipped with a 120V 3-wire pigtail, only a portion of which was still attached to the dryer. The power cord insulation was entirely consumed. The severed ends displayed mechanical damage, indicating they were cut or broken after the fire. The plug end was included with the other evidence items and was still plugged into the single receptacle from the wall of the laundry room. There was no sign of electrical activity on the power cord or at the power cord connections.

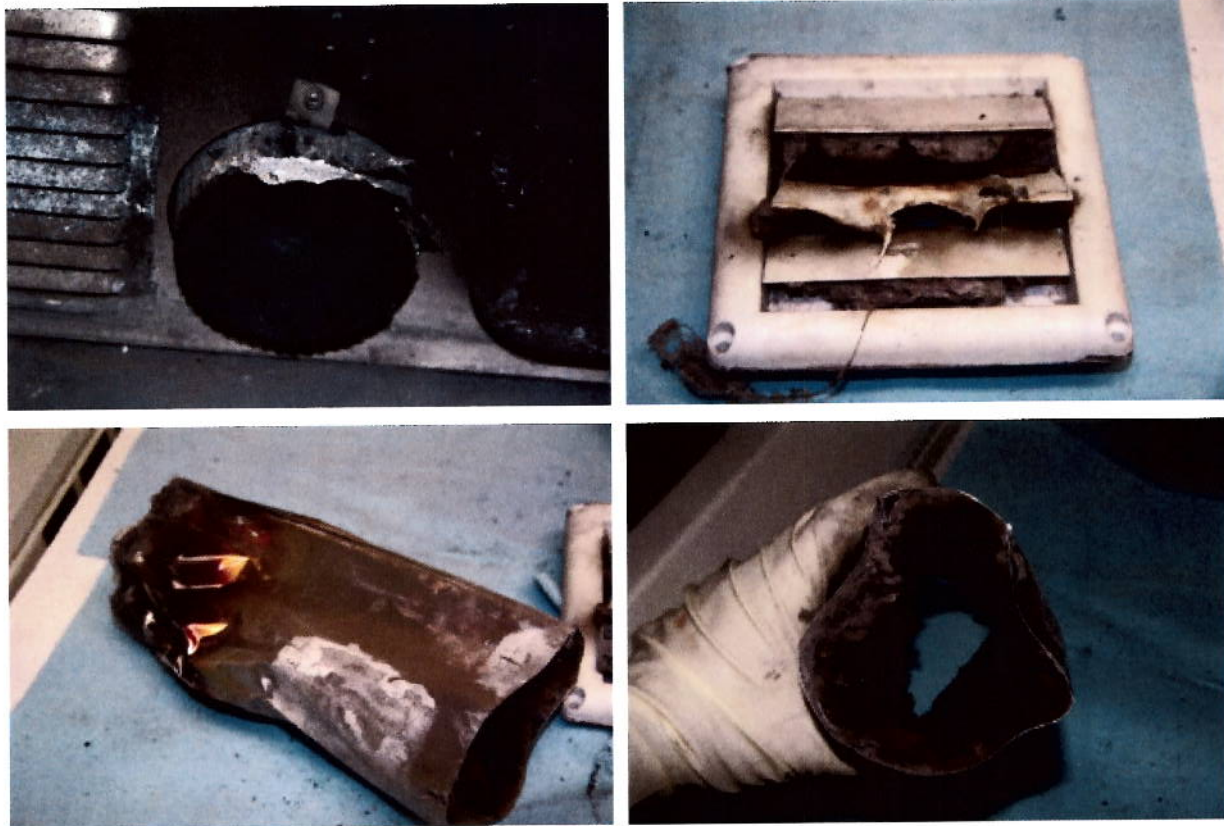
**Exhaust Duct Components**

There was a small section of flexible foil transition duct remaining attached to the exhaust connection at the rear of the dryer cabinet. With the exception of the small amount of foil material attached to the rear of the dryer, the remainder of the transition duct was not included for examination or did not survive the fire. Based upon the scene photographs it is evident that the flexible foil duct was attached to the rear of the dryer, took a 90° bend and ran to the left side of the dryer, made a sweeping bend before attaching to the louvered vent at the exterior wall. The flexible foil duct was estimated to be approximately 3-4 feet long. Also included with the evidence was the louvered exterior vent assembly, which contained a heavy amount of soot-blackened lint. The plastic louvers were only slightly melted.

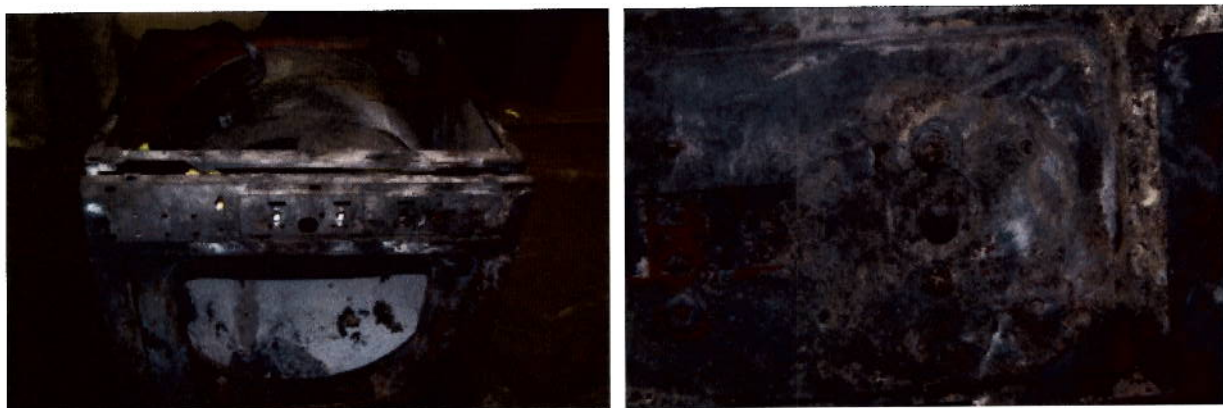
**Control Console**

The front mounted control console had been heavily damaged by fire. All three control knobs had been consumed. This made it impossible to assist in the verification of the dryer settings at the time of the fire. In addition, the timer body was completely destroyed. This made it impossible to examine the position of the timer shaft or to conduct a continuity test on the timer to determine its setting.

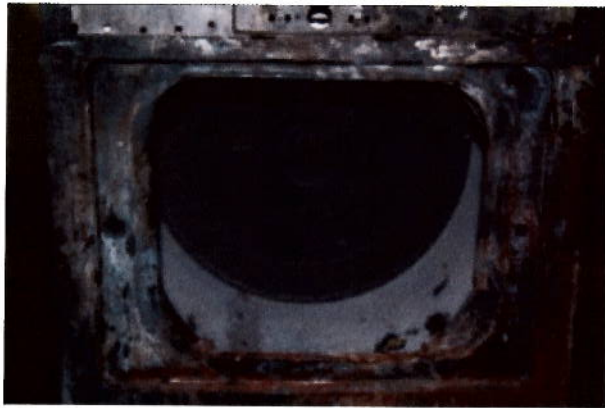
**Drum Opening**

The drum opening was examined and the door switch, door catches and the manufacturer's labels had been consumed. The door was not attached nor was it included with the evidence. The lint filter and lint trap had been entirely consumed during the fire. The drum did not contain a load line, which was consistent with the report that the housekeeper had removed the contents of the drum after she discovered the fire. All three plastic drum paddles had been consumed.

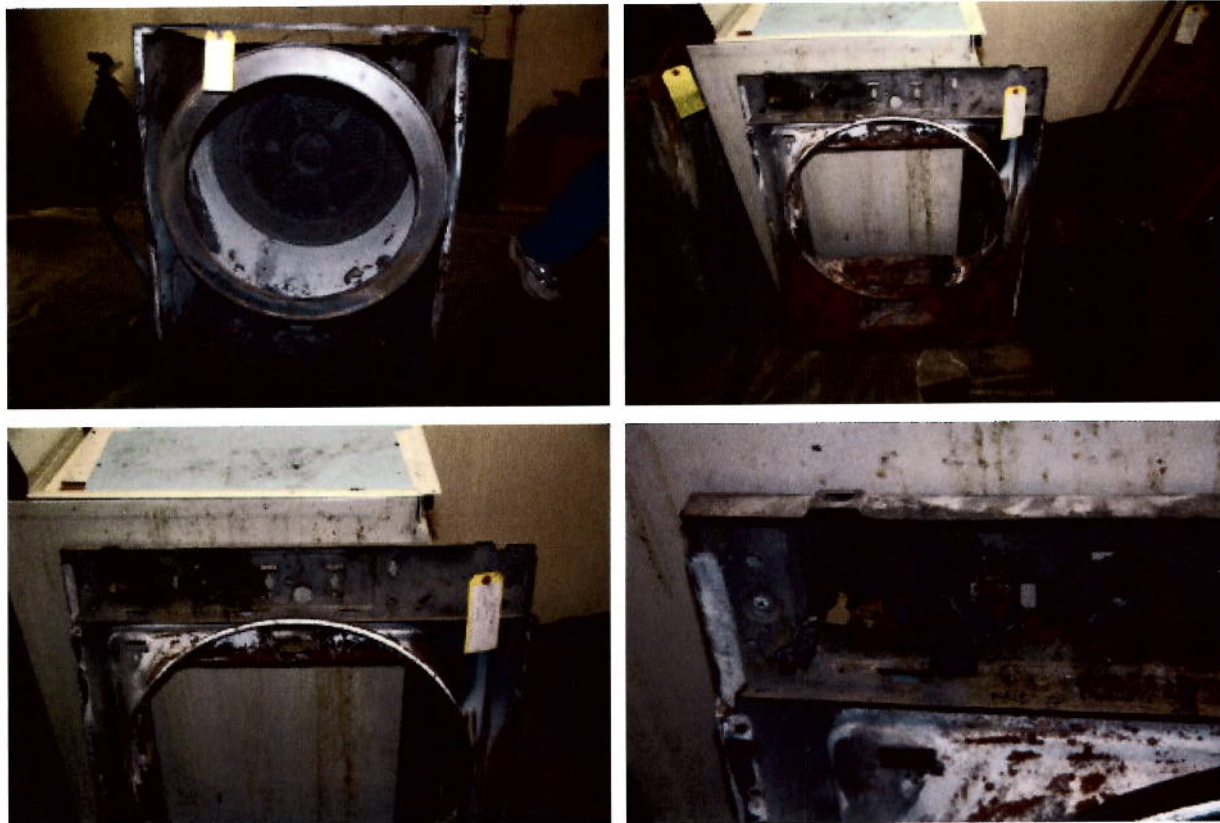
**Front Panel Removed**

The dryer top had not been installed on the appliance at the time of the fire. Examination of the top of the dryer revealed that the interior panels are fire damaged. The belt was consumed. The witness marks on the drum reveal the belt was in place at the time of the fire. The front panel screws were missing and had been removed post fire during a prior examination of the dryer. The front panel was removed from the dryer to allow further inspection of the interior of the front panel. The majority of the conductors and components from the wiring harness in the area of the front-mounted control console was also missing and could not be evaluated for the

presence of electrical activity. No electrical activity was observed on the remaining conductors. The plastic trap duct had been entirely consumed, as had the plastic blower housing at the right front corner of the cabinet.

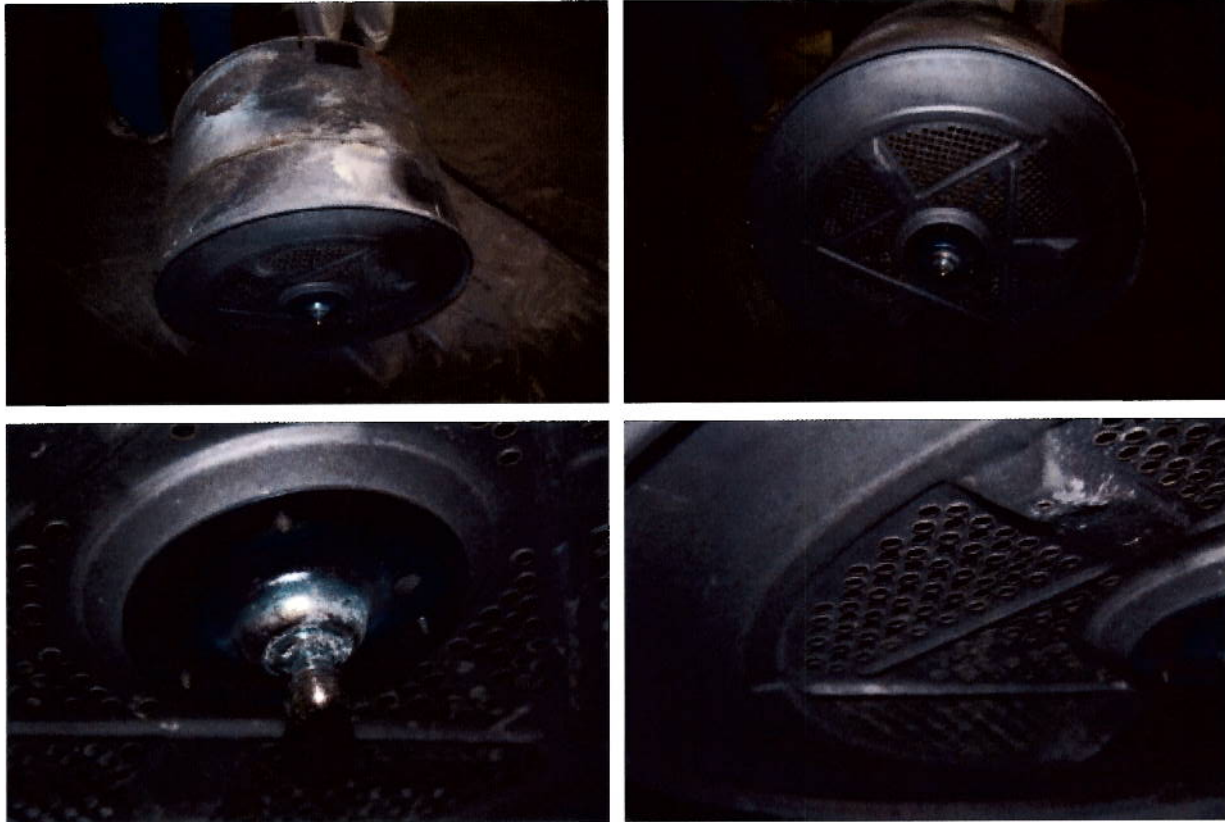
**Rear of the Drum**

Examination of the drum reveals the drum pivot shaft is fully intact and undamaged from mechanical scoring. The rear of the drum was not equipped with a heat shield/baffle. There was no accumulation of lint remaining on the rear of the drum surrounding the numerous perforations at the time of this inspection. Any additional lint that usually collects in this area was likely consumed during the fire or dislodged from firefighting efforts or evidence collection and transport.

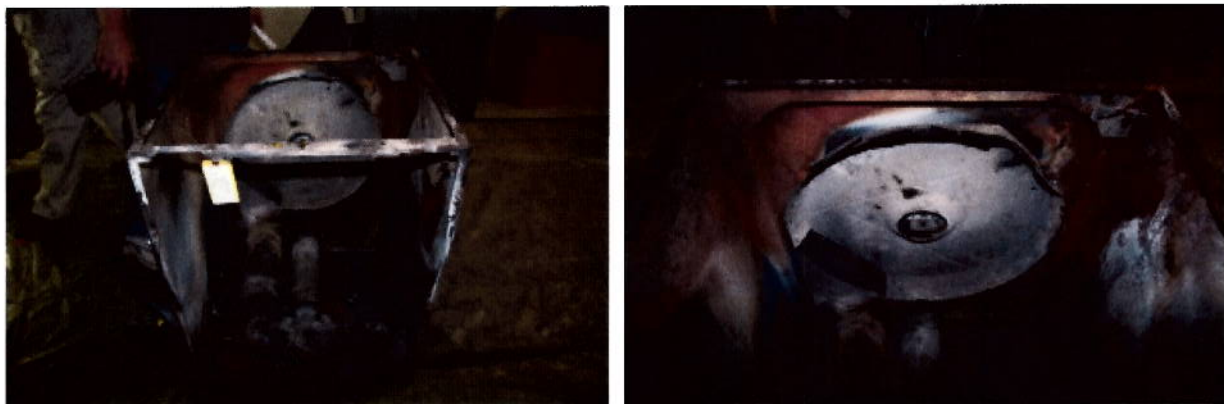
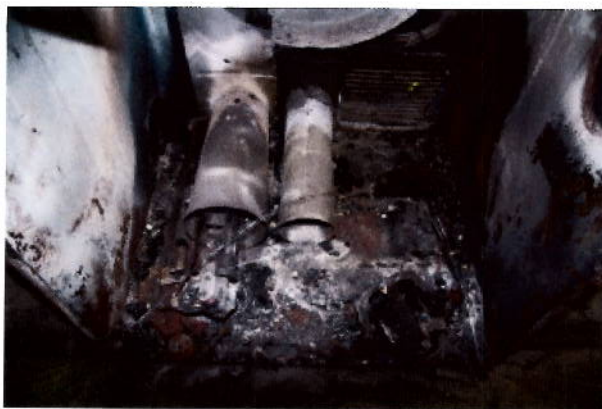
**Interior of Cabinet**

Examination of the interior of the cabinet with the drum removed reveals the floor of the cabinet was mostly devoid of lint. The plastic blower housing and plastic fan impeller had been consumed, and a minor amount of the melted plastic remaining had re-solidified along the floor of the cabinet. The motor had shifted positions during removal from the home or during evidence transport.

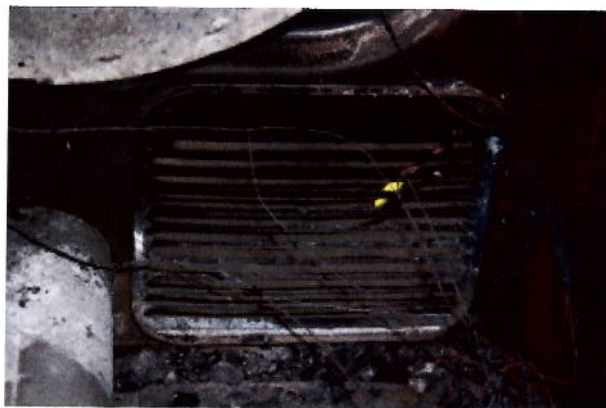
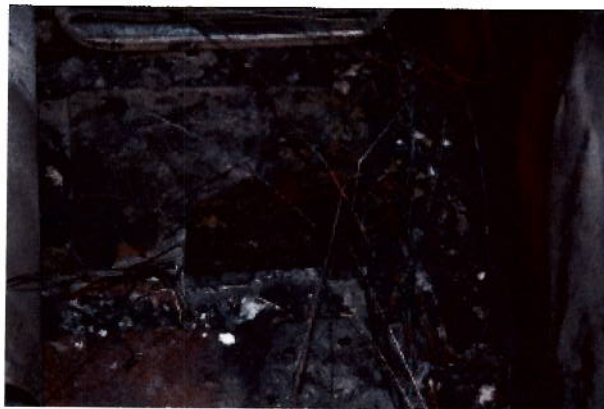
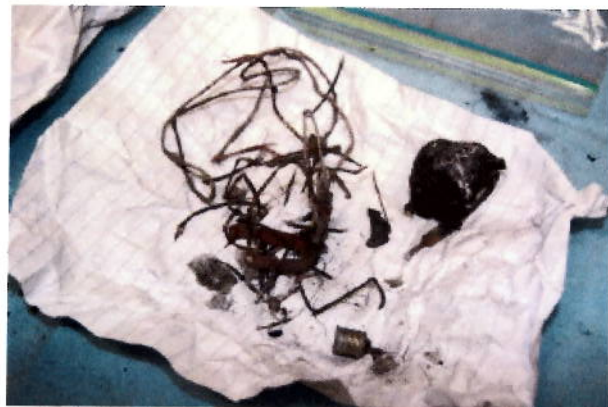
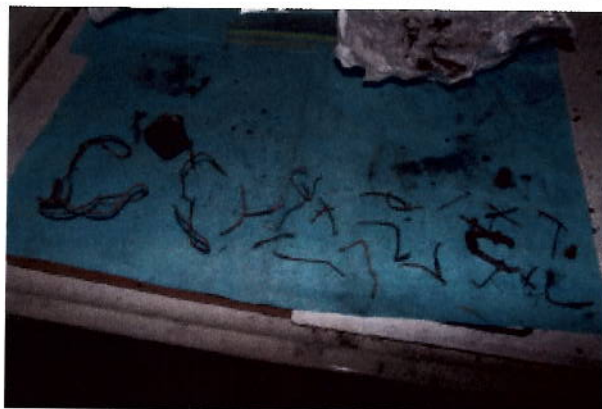
**Wiring Harness and Loose Wiring**

The remainder of the wiring harness was examined. The majority of the wires from within the cabinet were found loose in the base of the appliance. The insulation had been entirely consumed. Two of these loose conductors showed signs of electrical activity. The presence of electrical activity indicated that the dryer was energized during the fire.

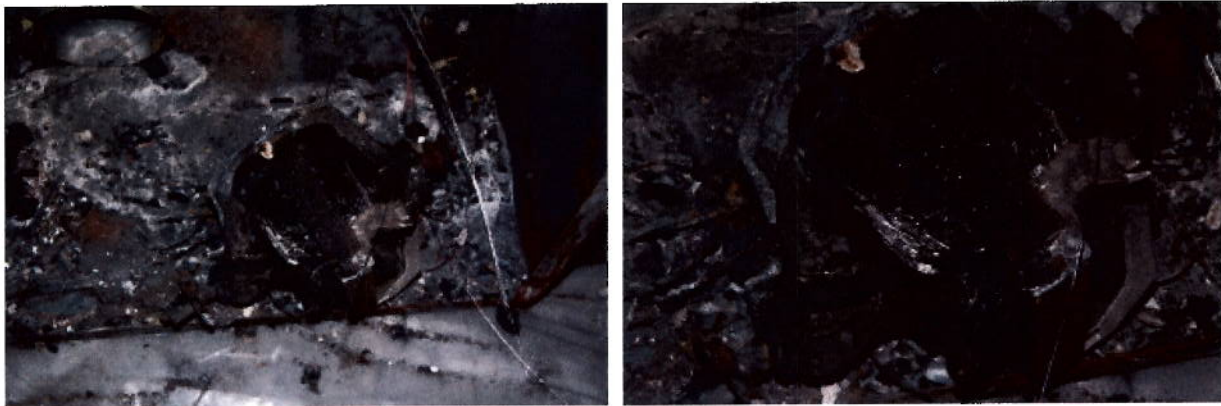
**Motor**

Examination of the motor reveals that it was displaced from its original position by firefighting efforts and/or transport. The windings were intact and were slightly discolored from external heat damage. There was no lint on the motor. The alloy frame of the motor was melted and partly consumed. There was no sign of electrical activity on the windings or the attached conductors. The shaft of the motor could not be manually rotated due to the front bearing and frame damage. The centrifugal switch was consumed and could not be manually tested.

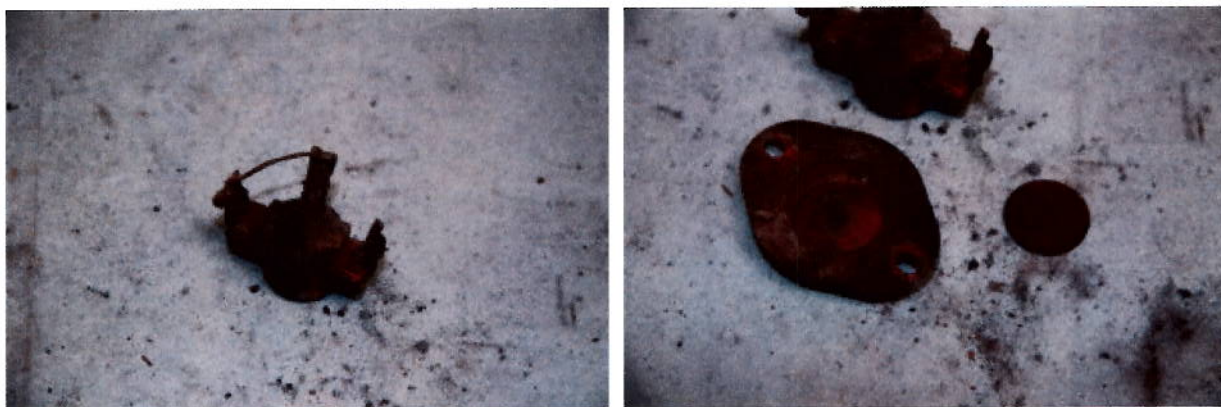
**Operational Thermostat**

The operational thermostat was not found amongst the plastic blower housing at the front of the cabinet that was consumed during the fire, but was found loose in the cabinet. The operational thermostat had been consumed during the course of the fire, making it impossible to test for operation.

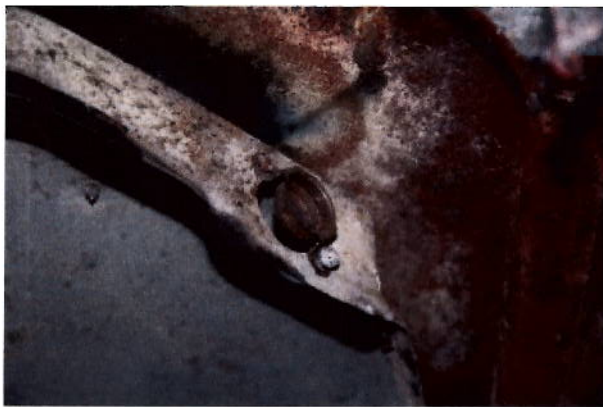
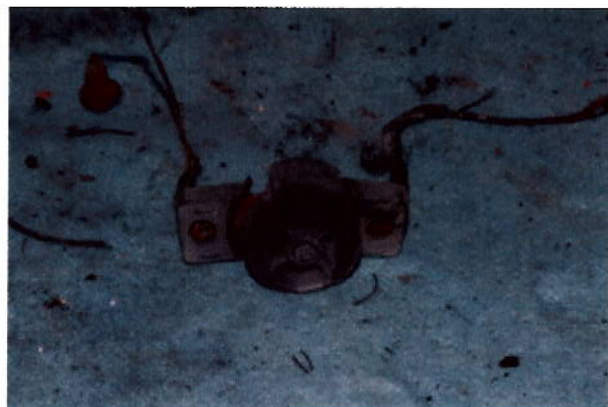
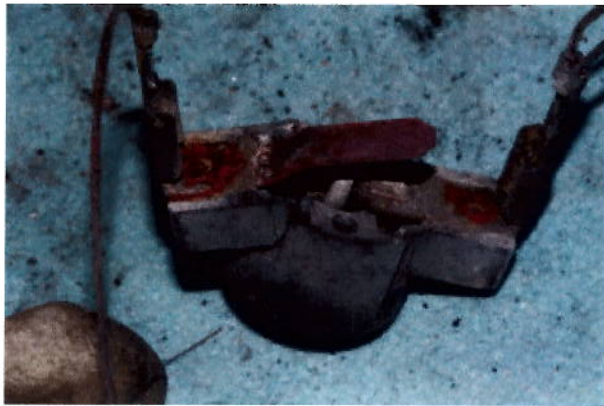
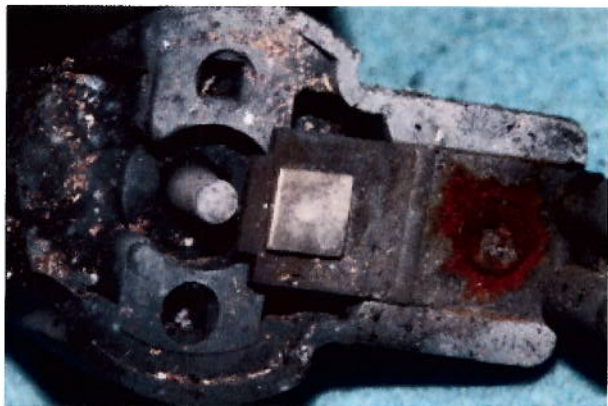
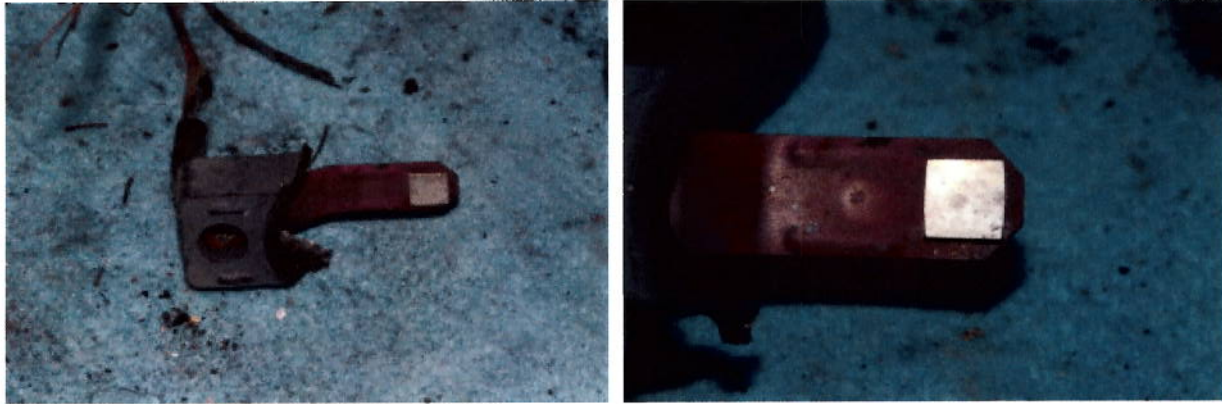
**High Limit Safety Switch**

Examination of the automatic resettable high limit safety switch that had been located at the one o'clock position of the heat diffuser pan revealed that it was heavily damaged and broken apart. The high limit's contacts were found loose in the base of the cabinet. In addition, one of the screws that secured this component to the heater housing was not in its OEM position. This indicated it was either manipulated during a prior examination, or had loosened as a result of the fire, firefighting activities or evidence transport. The insured indicated that the dryer had never been serviced, so manipulation of this screw during service was ruled out. The typical rating for this high limit safety device is L180-40F. Due to the damage, the automatic resettable high limit safety switch was not operationally tested. A visual inspection of the contact surfaces was conducted and no evidence of cycling was observed on the contacts. Based upon these observations it was clear that the automatic resettable high limit safety switch had not been operating repeatedly due to deficient airflow over the lifetime of use. This does in no way support that the dryer was improperly installed as related to the lack of the top lid when it was installed under counter, or that the exhaust system was overly restricted.

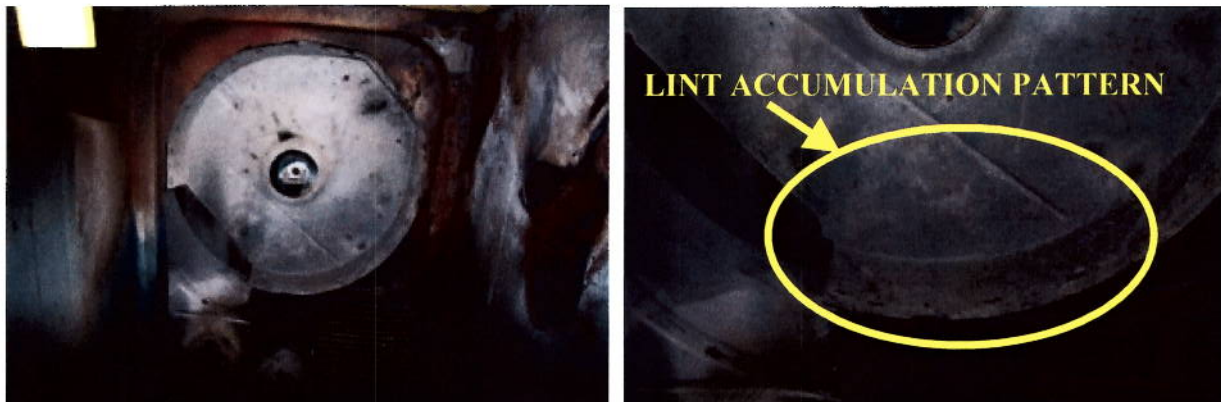
**Heat Diffuser Pan and Right Edge of Vertical Heat Duct**

Examination of the heat diffuser pan mounted to the rear of the cabinet revealed no charred lint remaining inside at the time of this inspection. The heavy heat damage and oxidation of the metal was consistent with heavy fire damage that would have consumed a majority of this lint. An area of localized oxidation was observed at approximately the six o'clock position of the diffuser pan. This was consistent with a large quantity of lint being present there at the time the fire originated. A mass of partially unburned lint was also observed in the base of the cabinet in the area of the burner assembly and was determined to have been dislodged from the 6 o'clock position of the diffuser. This evidence of lint accumulation (first fuel) is in proximity to the heat source (burner flame) and was determined to be the first fuel ignited, though it was consumed during the fire and/or dislodged during firefighting operations and/or evidence transport.

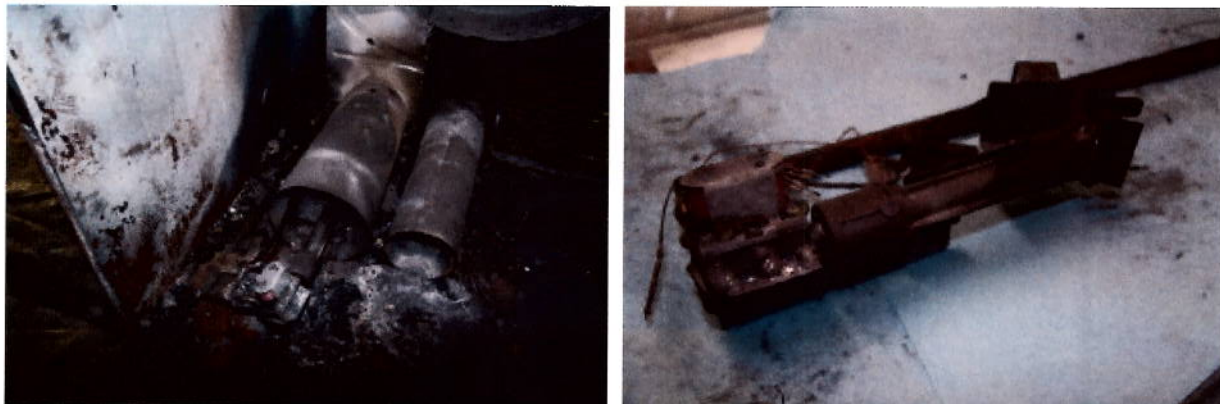
**Gas Burner Assembly**

Examination of the burner tube and gas burner assembly revealed these components had no accumulation of lint on them. If any lint had been present, it would have been consumed during the fire, as this area was heavily fire damaged. The air shutters for the burner nozzle were examined but neither the upper or lower shutter was blocked by lint. The gas valve assembly displayed heat damage to the components. A pressure test was conducted of the gas train but failed to hold pressure. The leak was determined to be the result of fire attacking the gas valve. This indicates there was no malfunction of the gas valve or burner assembly that would allow for the uncontrolled escape of gas pre-fire, but rather occurring as a result of the fire. The gas train was removed for further examination and the burner assembly was found to be equipped with a size 44 orifice, which is appropriate for natural gas. As previously mentioned, unburned lint was observed in the burner tube, at the base of the vertical heat duct. This lint had entered this area after the fire, during firefighting operations or evidence transport.

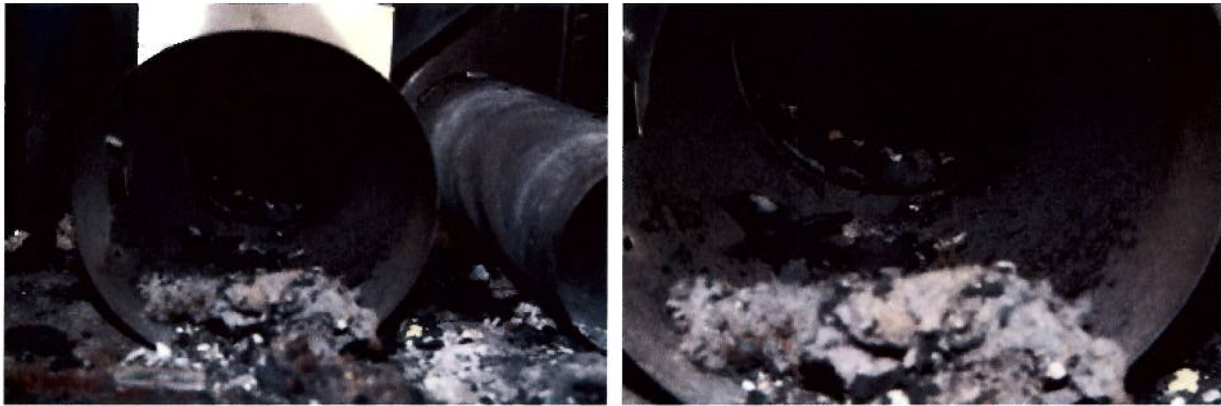
**Lint Within Burner Tube**

Based upon this evidence examination, it is determined that the fire originated within this Electrolux gas-fired dryer. No causes could be identified relating to any electrical or mechanical failures of the internal components. Based upon the information provided, the fire was first observed in the area of the trap duct. The dryer was most probably operating at the time of the fire but was off during the fire, either by the housekeeper turning the timer off upon fire discovery or when the door was opened. The housekeeper also removed the load from the dryer, removed the lint screen and attempted to extinguish the fire by pouring water into the trap duct. In addition to the information provided that the load was removed upon fire discovery, the fire patterns do not support a drum fire. Therefore, contamination of the load by combustible liquids or materials prone to spontaneous combustion was eliminated as a cause to this fire. The only remaining ignition scenario is the ignition of accumulated lint within the dryer by the burner flame.
